Preliminary investigation of seismic damage to two steel space structures during the 2013 Lushan earthquake

Abstract: Severe damage to steel space structures is rarely reported when compared to other structural systems damaged during past major earthquakes around the world. Two gymnasiums of steel space structures in downtown Lushan County that were damaged during the 2013 *M*7.0 Lushan earthquake in China were investigated and the observations are summarized in this paper. Typical damage to these two steel space structures ranges from moderate to severe. Moderate damage includes global buckling and dislocation of bolted connections of truss members, and inelastic elongation of anchor bolts and sliding of pedestal plates of supports. Severe damage includes member fracture caused by local buckling, and fracture failure of anchor bolts and welds. The distribution of structural damage to these two structures is described in detail and future research opportunities are suggested.

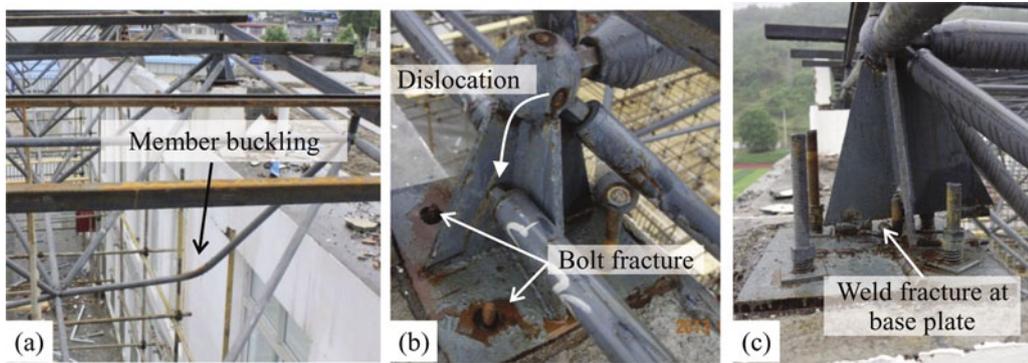
Fig. 2 Typical damage to truss members in Structure A

The Lushan Middle School gymnasium is a two-story reinforced concrete (RC) moment-resisting frame building that was designed and constructed after the 2008 *M*8.0 Wenchuan earthquake, with financial support from Macao. Its first story was occupied as a café and its second story was a gymnasium that included a basketball field. The roofing system is a double layer steel grid structure (denoted as Structure A, hereafter) resting on eighteen supports on top of the RC columns (Fig. 1). The double layer grid is composed solely of square pyramids. The bolted spherical bearing at each support is welded to a cruciform steel stand with a base plate fastened to a steel plate embedded in the top of the RC column by four ϕ 24 anchor bolts. The top layer of the grid was covered by profiled steel sheets, which were heavily damaged during the earthquake and had been removed at the time of inspection about three weeks after the earthquake. Primarily as a result of the loss of the roof, the occupancy of the building was suspended after the earthquake, although the RC frame structure remained essentially intact. In addition, Structure A sustained severe seismic damage including global buckling (Fig. 2(a)) and dislocation of truss members

(Fig. 2(b)), fractures of the anchor bolts at the base plates (Fig. 2(b)) and weld fractures of the support (Fig. 2(c)).

vulnerable to either tensile or compressive damage than the chord members. In particular, six of the web members that were connected to the supports sustained both global buckling and connection failure, indicating significant tensile and compressive load reversals during

the earthquake. The buckling of these web members, which should remain in tension under gravity load, indicates that vertical ground motions may have lifted the steel grid up, subjecting them to significant compression.

All eighteen supports sustained various damages and twelve of them failed because of weld fracture. Most fractured at the spherical bearing while one fractured at the weld between the base plate and the cruciform steel stand, which should have been much stronger than at the spherical bearing (Fig. 2(c)). Such unexpected damage may be attributed to poor quality control of the welding.

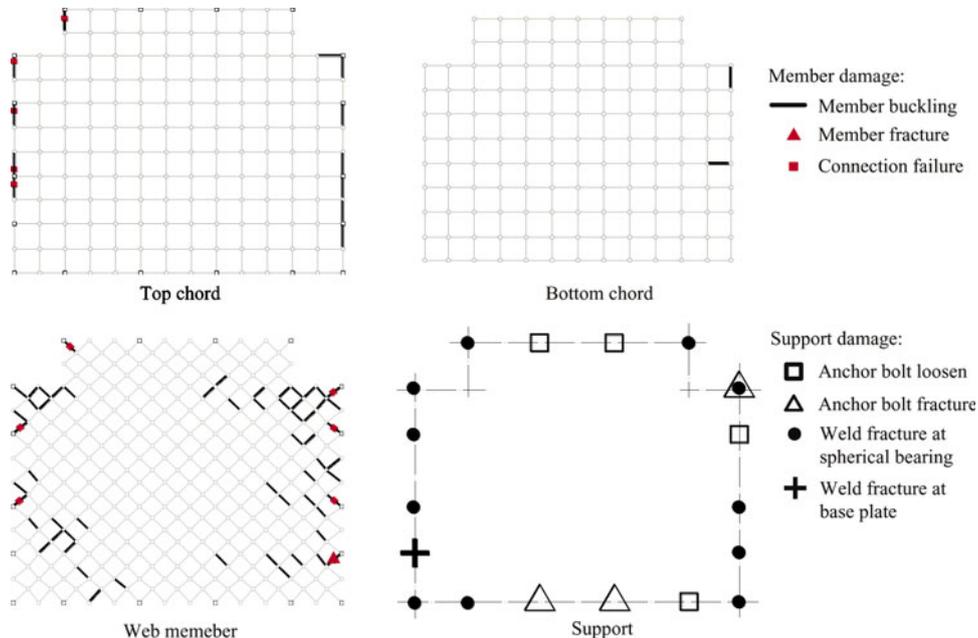
Fig. 3 Damage distribution observed at four different levels of Structure A

Figure 3 depicts the distribution of observed damage to the truss members as well as to the supports. As with the truss members, web members seemed to be more

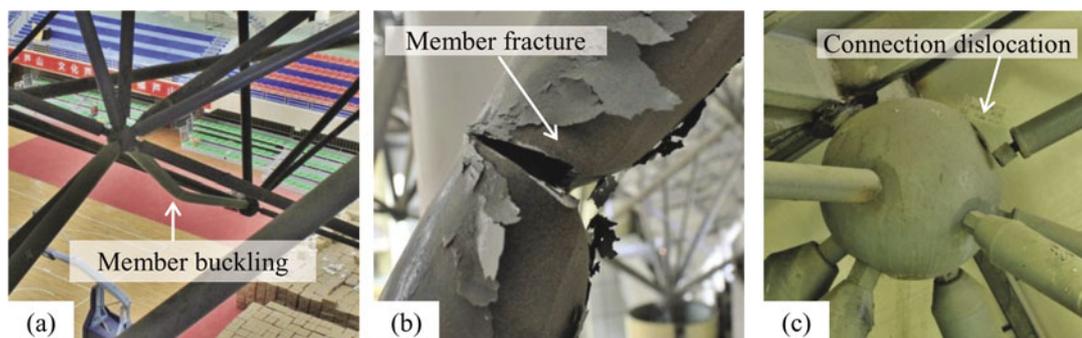
Fig. 5 Typical damage to truss members in the lattice shell structure of Structure B

Similar to Structure A, typical damage to the truss members in Structure B include global buckling (Fig. 5(a)), steel fracture (Fig. 5(b)) and failure of bolted connection at spherical nodes (Fig. 5(c)). The seismic damage to the supports of Structure B were not as severe as to Structure A. Slight loosening and offset of the anchor bolts were observed on 19 of the 22 supports on top of the RC columns, while inelastic elongation and fracture of the anchor bars were found on two of the nine supports on the ground.

made of steel tubing 114 mm in diameter and 4 mm in thickness. Three hinges formed because of steel fracture at both ends and in the middle of the strut (Fig. 5(b)). Note that the support to which the fractured strut was welded is located on top of a three-story masonry-infilled RC frame building attached to the inside of the gymnasium. The large lateral stiffness of the attached building very likely caused force to be concentrated on the supports on top of the building, and thus exacerbated local damage to the struts that were there.

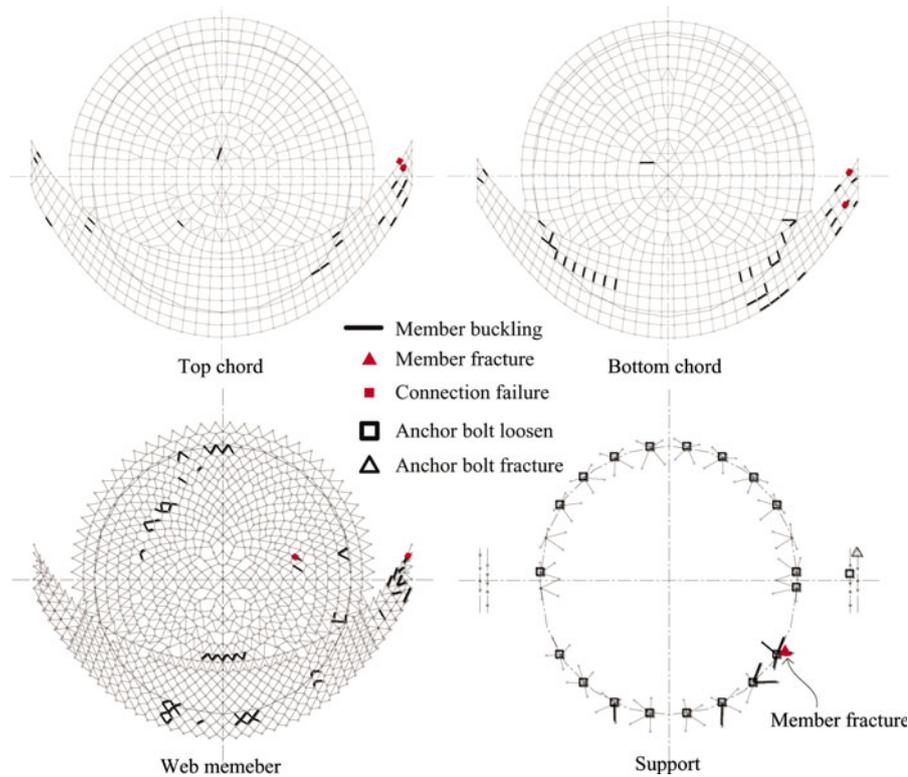
Fig. 6 Observed seismic damage distribution of steel lattice shell of Structure B

Figure 6 shows a distribution of the observed seismic damage on the space roof structure and its supports. Visual inspections identified damage to 131 truss members in the steel lattice structure, including 17 top chords, 36 bottom chords, 70 web members and eight supporting struts. In addition, some moderately or severely damaged members that were difficult to see may have been missed during the inspection. The damage to the fixed based arch was generally more significant than to the dome, which rests on flexible rubber supports. The joint zone of the dome and the arch seems more vulnerable to seismic effects than other parts of the lattice shell. The most severe damage to the truss members was observed on a supporting strut located at a corner where the arch meets the dome as indicated by a solid triangle in Fig. 6. The fractured strut is 3,202 mm long and is
