## ***TECHNICAL NOTE***

# **Seismic Damage of Masonry Infilled Timber Houses in the 2013 M7.0 Lushan Earthquake in China**

**Zhe Qu,<sup>a)</sup> M.EERI, Andreea Dutu,<sup>b)</sup> M.EERI, Jiangrong Zhong,<sup>c)</sup> Jingjiang Sun<sup>c)</sup>**

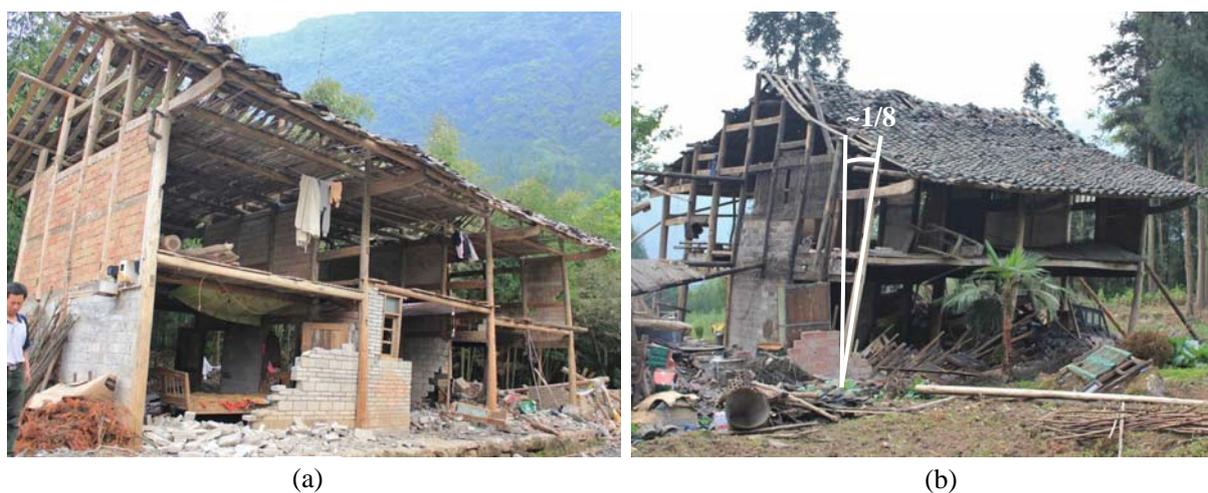
Cracking and collapse of masonry infills were the most commonly-seen damage to the masonry infilled timber frame houses. In the two examples shown in Figure 7, both houses lost many of the masonry infills in their longitudinal direction but neither of them fully collapsed, partly owing to the dual nature of the structural system. Such behavior is substantially different from that of URM structures, in which the masonry walls provide the sole resistance for both the vertical loads and the earthquake lateral load. Severe shear cracking of the masonry walls due to lateral load would at the same time greatly degrade their vertical load-bearing capacity and may eventually lead to the collapse of the house.

**Figure 7.** Collapse of masonry infills in masonry infilled timber frame houses: (a) moderate damage and (b) severe damage.

Different from the timber frame in Figure 7(a), which was almost intact and needed no repair after the earthquake, the one in Figure 7(b) leaned so significantly towards one side that it became very difficult to repair. The residual drift ratio was about 1/8. At such large

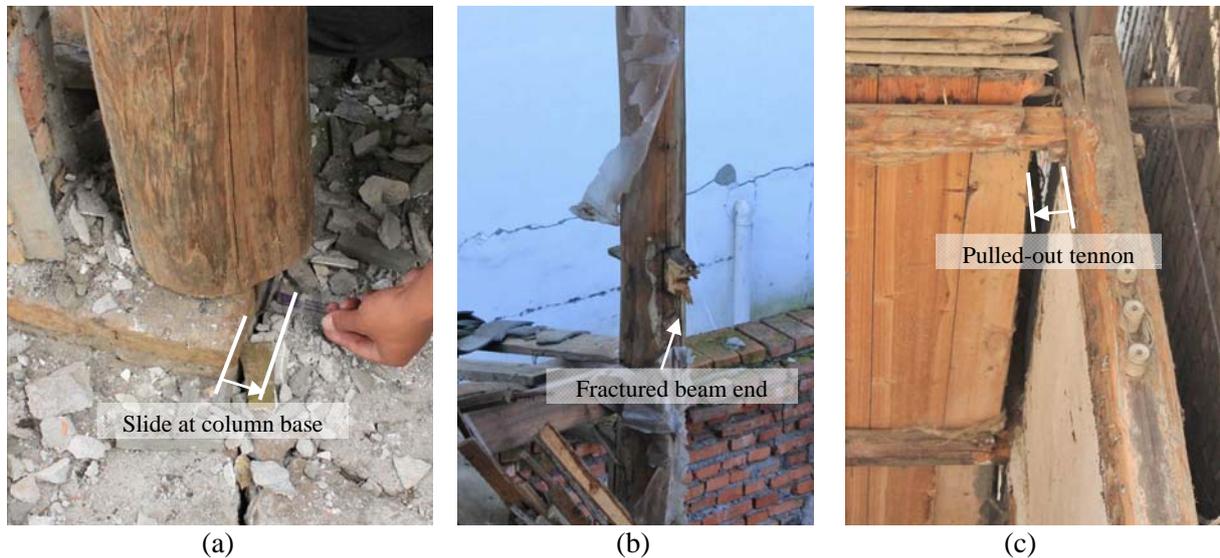
drift, the timber frame must have also sustained some damage. Most commonly seen damage patterns of the timber frame are demonstrated in Figure 8(a) to (c). They include the frictional sliding at the column base, the fracture at timber beam end, and the pull-out of the tenon from the mortise. Such damage might be attributed to the poor detailing, corroded materials or other factors like the loss of too many masonry infills. Once they took place, it is not easy to restore the full occupancy of the house without substantial repair efforts.

**Figure 8.** Typical damage to timber frame: (a) sliding at column base; (b) fracture of beam tenon and (c) pull-out of beam tenon.

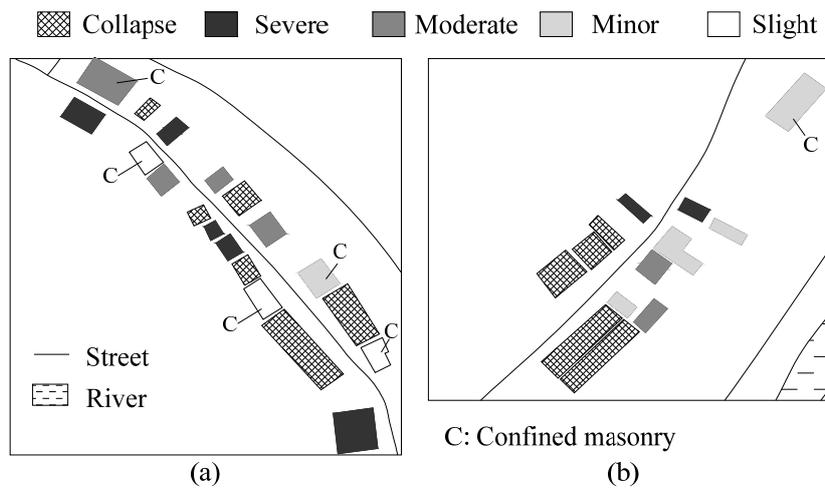
Among the 32 inspected masonry houses shown in Figure 7, six were classified as confined masonry (denoted by ‘C’). The results indicate that such confining elements, although not necessarily rigorously designed, were quite effective in reducing the seismic damage of the masonry houses. In contrast to the considerable damage to the URM houses, 5 out of the 6 confined masonry houses sustained only slight or minor damage.

**Figure 10.** Damage levels of inspected masonry structures in (a) Zone 1 and (b) Zone 2.

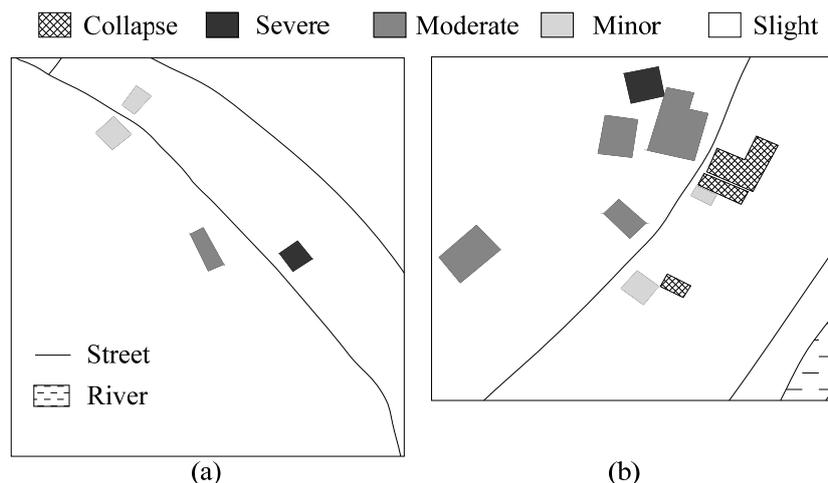
**Figure 11.** Damage levels of inspected masonry infilled timber houses in (a) Zone 1 and (b) Zone 2.

The structural system of masonry infilled timber houses were subjected to less uncertainty as compared to masonry houses. Statistics of damage levels of the inspected houses shows that moderate damage predominated in masonry infilled timber frames in the current case study (Figure 11), which may be either minor damage of the timber frame itself or substantial damage of the masonry infills, or both, as per Table 3. The ratio of severe damage and collapse of timber houses is only 34%, much lower than that of the URM houses (75%).

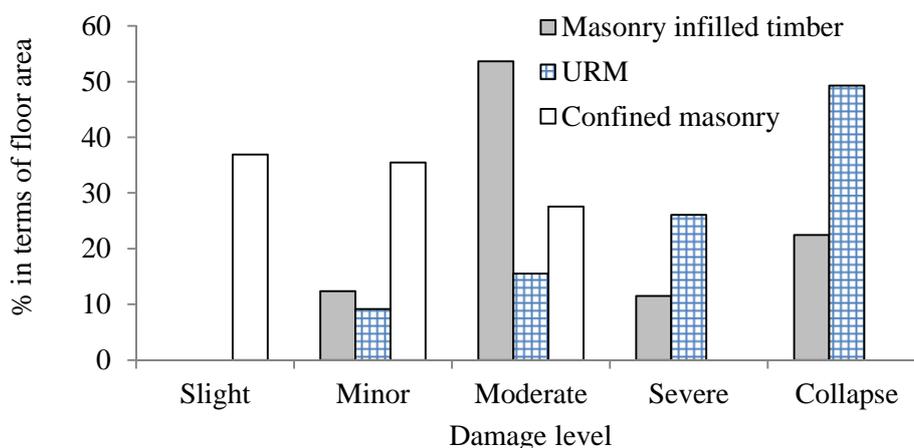
Masonry infilled timber frame houses and URM houses are the two most widely used and un-engineered structural systems in underdeveloped rural areas like Shuangshi in southwestern China. The comparison in Figure 12 clearly shows the advantage of timber houses in terms of seismic performance over URM ones, although the joint detailing has been oversimplified through the history. This can be attributed to the inherent dual system of masonry infilled timber frame houses. A lot can be learnt from this ancient structural system and improved detailing should be encouraged to further enhance its seismic performance and to restore its vitality as a practical solution for small scale residential houses in underdeveloped regions.

**Figure 12.** Damage level statistics of masonry houses and masonry infilled timber houses in the inspection zones
