Analysis on Building Seismic Damage in the Wenchuan Earthquake

Ye Lieping, Lu Xinzheng, Qu Zhe, Feng Peng

Department of Civil Engineering, Tsinghua University, Beijing 10084 China

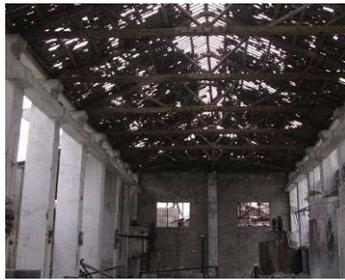
A factory in Anxian

This type of structure is widely used in single-story factories, warehouses and residential houses in the rural area for its cheap materials. These buildings are usually old and lack of maintenance. The strength of most of their masonry walls and columns can not meet the requirements of current building codes. They are

vulnerable to overall and partial collapse in the earthquake. See Figure 1.

Fig. 1 Seismic damage of masonry structures with timber roof

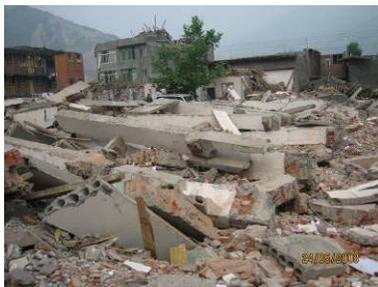
Collapse of the teaching building of Nanba primary school, Nanba

Fig.2 Seismic damage of RC-strengthened masonry structures

Most residential buildings, school buildings in the rural area, and some of factories, old residential and office buildings in the cities use the reinforced masonry structures, which is the most common structure type in the earthquake area. A lot of buildings of this structure type collapsed or were heavily damaged in the earthquake. Some general reasons of its vulnerability are: poor redundancy of structural system, lack of concrete structural columns and ring beams, poor connections of pre-cast slabs and so on. Figure 2 shows some typical damages of such structures. Some undamaged or slightly damaged buildings with this structure type could also be seen in the meizoseismal area. This proved that buildings with this structure type are able to survive the great earthquake only if the earthquake-resistant measures such as concrete structural columns and ring beams are ensured. To enhance the wholeness and lateral resistance is the key issue in the design of such structures.

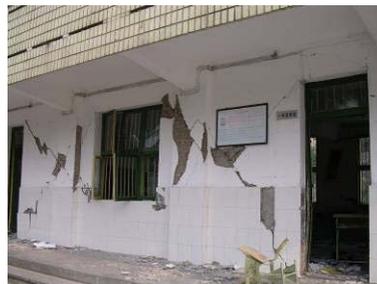
Severe damage in the load-bearing walls and columns of the teaching building of Huayuan St. Middle School, Jiangyou

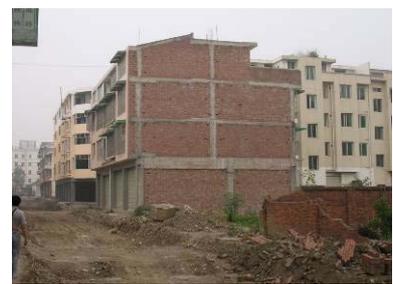
Undamaged masonry structures with concrete structural columns and ring beams in Anxian

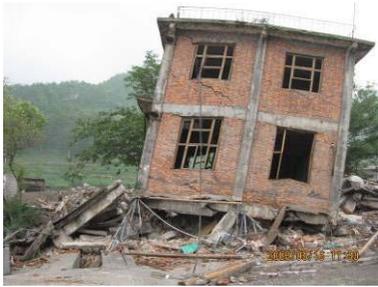
A gas station using masonry structure with bottom RC frame, Hongbai

Fig.3 Seismic damage of RC frame-masonry hybrid structures

There're many hybrid layouts including vertical hybrid such as masonry structures with bottom RC frames, and horizontal hybrid structure with partial RC frames and partial masonry structures. The load-bearing system, especially the lateral load-resistant systems of these structures are generally disordered and inconsistent in deformation between different parts. The vertical or horizontal stiffness of most of these structures is also badly distributed. Some common damages of these structures are: weak story collapse and the collapse of upside masonry structures. See Figure 3.

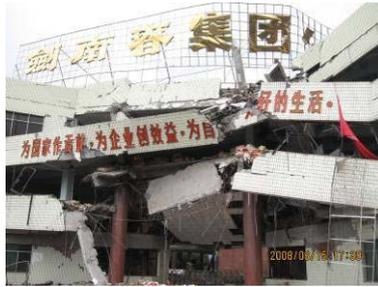
The damage of an office building using horizontal hybrid structure

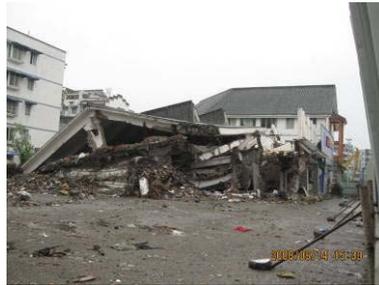
Collapse of a RC frame with a heavy roof, Dujiangyan

Fig. 4 Seismic damage in frame structures

The damage of most of the buildings with RC frame structures was not very severe in the earthquake. The damage mainly occurred in the enclosure structures and filler walls, especially circular filler walls. Such nonstructural damage also brings considerable economic loss and is even harmful to people's safety. Some RC frames collapsed in the earthquake due to poor construction quality or badly-designed structural system. The expected "strong column-weak beam" damage mode can be seldom found in the real damage, which may be the result of disregarding the strengthening effect of floor slabs and filler walls when the RC beams are designed. Figure 4 shows some typical damage in RC frames, including the shear failure of short frame columns in split-level buildings.

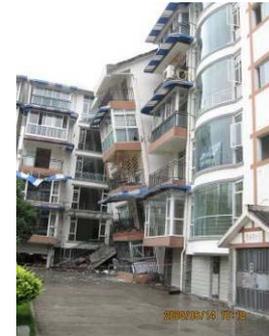
Weak story collapse of a RC frame

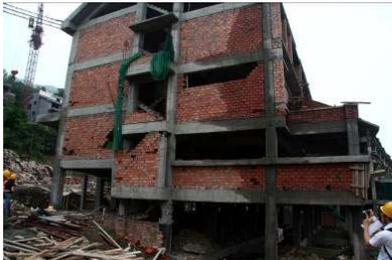
Shear failure of short columns in a split-level RC frames

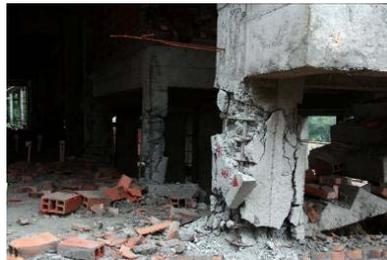
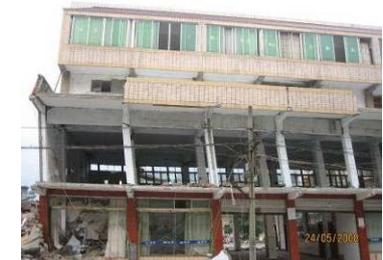
Plastic hinges in frame columns, Nanba

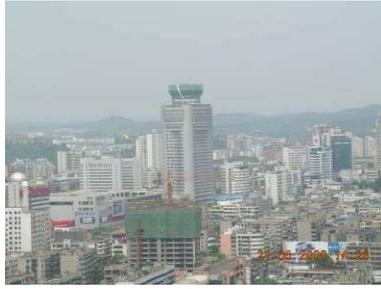
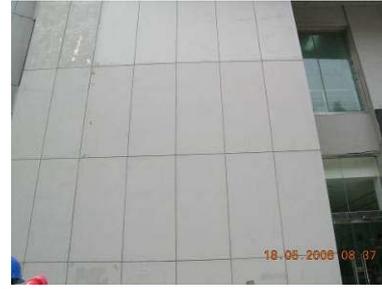
Fig. 5 Xinyi Building in Mianyang

This type of structure shows its advantage in seismic behavior in the earthquake. The damage of buildings with RC frame-shearwall (core tube) structures is very slight compared with that of nearby buildings with pure RC frame or other structures. Figure 5 is Xinyi Building in Mianyang city. Only some minor cracks were found in its enclosure walls in the earthquake survey.

(No damage in load-bearing structure. Only small cracks in some enclosure structures)

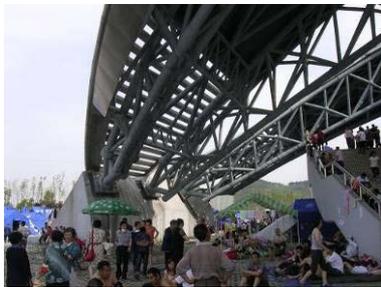
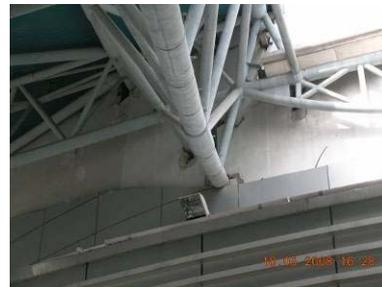
Fig. 6 Mianyang Jiuzhou Stadium

The damage of this kind of structures was very slight and occurred mainly in the enclosure structures. Figure 6 shows the Jiuzhou Stadium in Mianyang city. No damage was found in its major steel structure and concrete supports. Only some damage due to collision was found in the connections between the steel truss and enclosure walls.

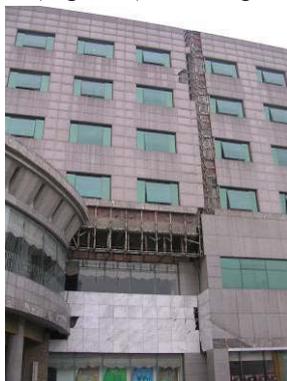
A hotel in Mianyang

Some other typical damage was found in the earthquake area including damage due to the collision in expansion joints (Figure 8) and whiplash effect (Figure 9).

Fig. 8 Collision damage in expansion joints

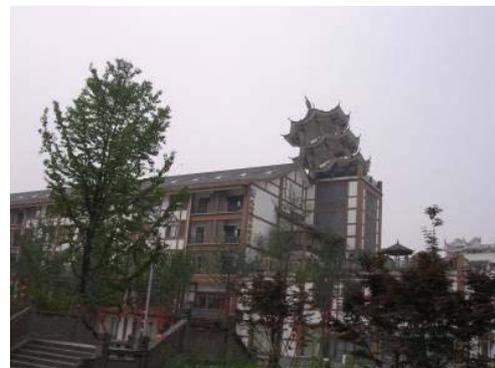
A public building in Dujiangyan

Fig. 9 Rooftop projection structural damage due to whiplash effect

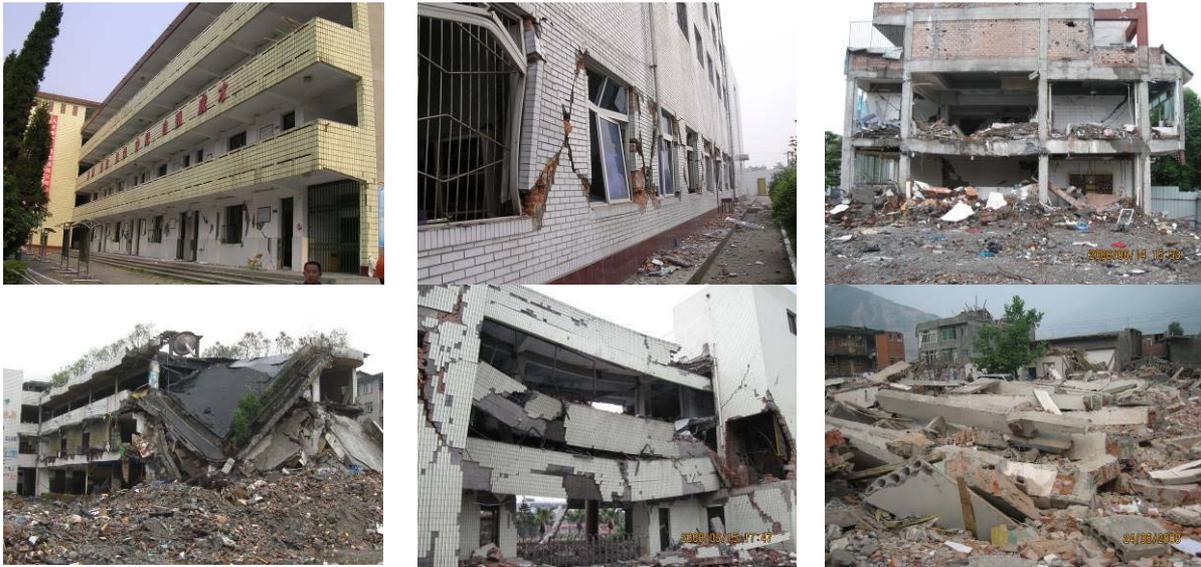
Fig 12 Different states of building damages beyond the design point against severe earthquake

Therefore, only the fundamental strength safety margin can be effectively ensured by current seismic design codes. The design concepts and engineering education about the integral and unexpected safety margins are very limited. It should be emphasized that the structural design is much more than the design of elements. But in the current engineering practice, most effort is devoted to the design of elements and the safety of building structures are not considered as an integral problem. Take the design of masonry structure for example. Brick walls are major load-bearing elements but they are brittle. So their failure is not stable. The ties between walls are usually ignored, resulting in the poor integral firmness. Concrete structural columns and ring beams can form an integral framework providing sufficient confinement to brick walls. They are very important to increase the system robustness, stability and firmness although they don't carry much load during normal service. Therefore, the fundamental strength safety margin, which is the focus of current design procedure, relies on the brick walls, but the integral and unexpected safety margin mainly come from the concrete structural columns and ring beams. Such a mismatch makes it easy for the engineers and constructors to ignore the structural wholeness. This is very dangerous for the structure under severe earthquake.
