Shake table tests of suspended ceilings to simulate the observed damage in the M_s7.0 Lushan earthquake, China

Wang Duozi, Dai Junwu, Qu Zhe, Ning Xiaoqing

Key Laboratory of Earthquake Engineering and Engineering Vibration, Institute of Engineering Mechanics, China Earthquake Administration, Harbin 150080, China

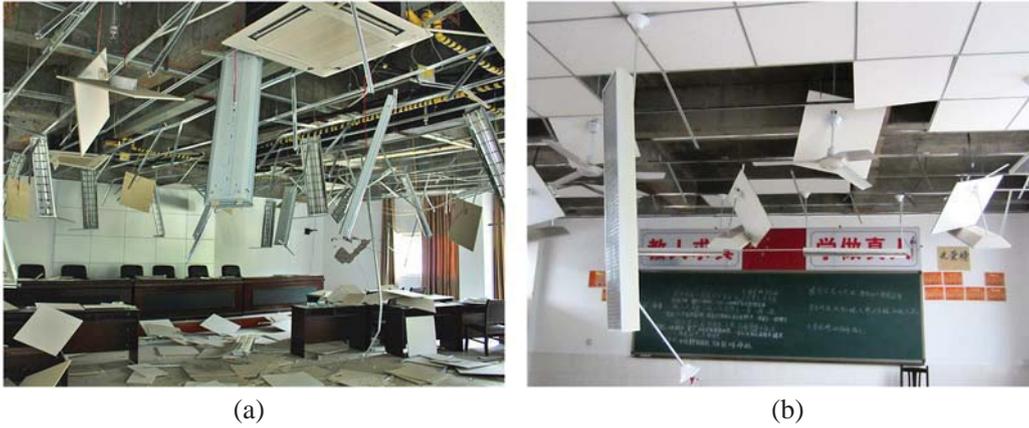
In particular, damage to suspended ceilings were found in most investigated public buildings ranging from single- or two-story low-rise reinforced concrete (RC) frames or masonry structures to multi-story RC frames for governmental offices, schools and hospitals (Figure 4). The extents of damage varied from complete collapse to sparse falling of ceiling panels. In slightly or moderately damaged ceilings, the perimeter panels seemed most likely to fall as a result of either the dislocation of closure angles (Figure 5) or the falling of main or cross runners from closure angles (Figure 6). This observation is consistent with the damage observed in the past earthquakes (ANCO 1983, Yao 2000). In some cases, closure angles were anchored in nonstructural partitions made of hollow bricks, which were highly vulnerable to seismic shaking. The cracking or distortion of such partitions would at the same time cause damage to the closure angles, triggering the falling of perimeter panels of the suspended ceiling, as is shown in Figure 6(b).

Fig. 4 Collapse ceilings in (a) the main meeting room of Lushan Radio and TV Center and (b) a classroom in Gaohe Middle School, Qionglai.

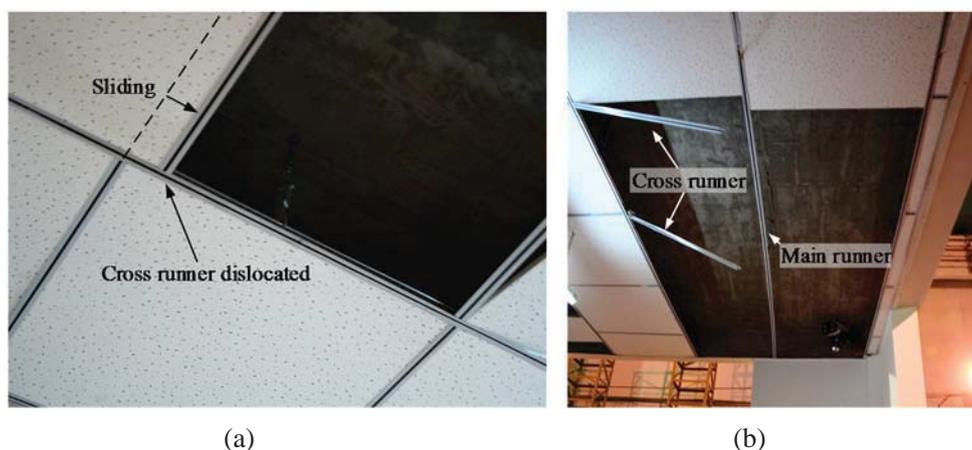
Similar to the damage observed after the Lushan earthquake, the joints of cross runners are most fragile in the tested ceiling grid. The joint may fail in horizontal shear under the push of a panel sliding along the main beam, as shown in Figure 16(a). In this case, the latches on both ends of a cross runner would fail at the same time. The cross runner may not fall immediately after the latches are sheared, but the integrity of the ceiling grid is weakened. In other cases, the latch at one end of a cross runner may be sheared off the main runner as shown in Figure 16(b). Soroushian et al (2015b) investigated the axial capacity of the latched joints of cross-to-main runners through static testing. Studies on the out-of-plane shear capacity of the joints have not been reported.

Fig.16 Damage to cross tees in shake table tests (run 7 and 8)

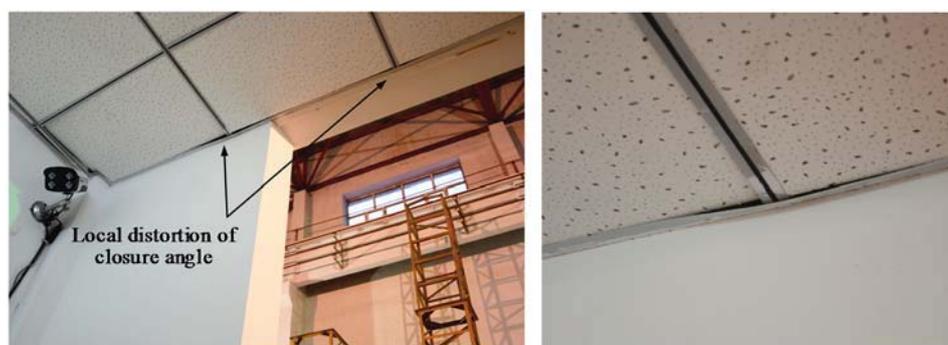
The main runners did not fall throughout the test. Besides, the closure angle in the current test also performed well. Figure 17 shows the only observed damage to the closure angles.

Fig.17 Damage to perimeter runners in shake table tests (run 5)
