SEISMIC RETROFIT OF DUCTILE CONCRETE MOMENT-RESISTING FRAMES WITH INNOVATIVE PIN-SUPPORTED WALL SYSTEM

Hiroyasu Sakata, Zhe Qu, Saburoh Midorikawa, Akira Wada
Tokyo Institute of Technology
Yokohama, Japan

Abstract

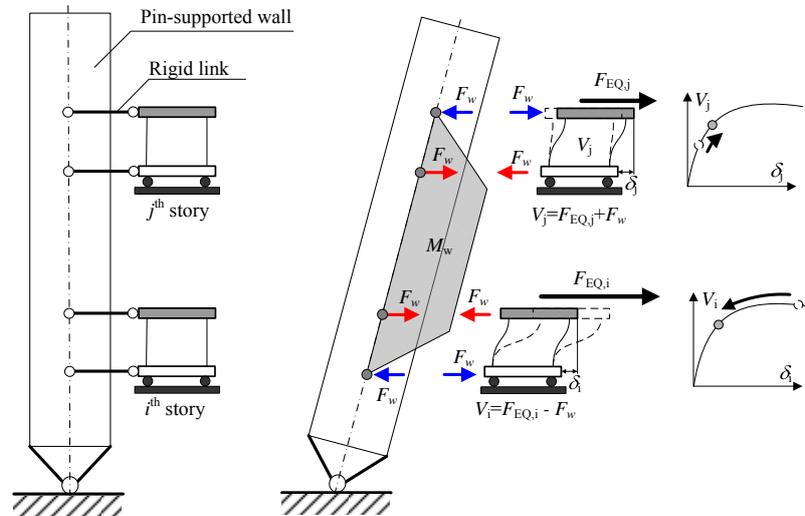
Figure 1 demonstrates a simplified dual system with a pin-supported wall and two single-story subassemblies, which are connected to the wall by horizontal links at different levels. In this model, the wall provides no additional lateral resistance. Assume that the strength of the i^{th} story alone is not adequate to resist the earthquake action $F_{EQ,i}$ on it and is expected to go deep into the plastic regime and sustain large deformation. With the help of the pin-supported wall, the lateral drift of this story will be forced to be similar to those of other stories by an additional resisting force of F_w provided by the wall. At the same time, the j^{th} story, where the strength is redundant, must resist an additional force F_w , which is imposed by the wall. Thus, the deformation of this stronger story is increased. In other words, weaker stories use strength from stronger ones so that they will not fail prematurely. At the same time, the pin-supported wall must carry the resultant shear force and moment so that this mechanism can be retained even during strong earthquakes.

Figure 1. Mechanism of deformation pattern controlled by pin-supported walls.

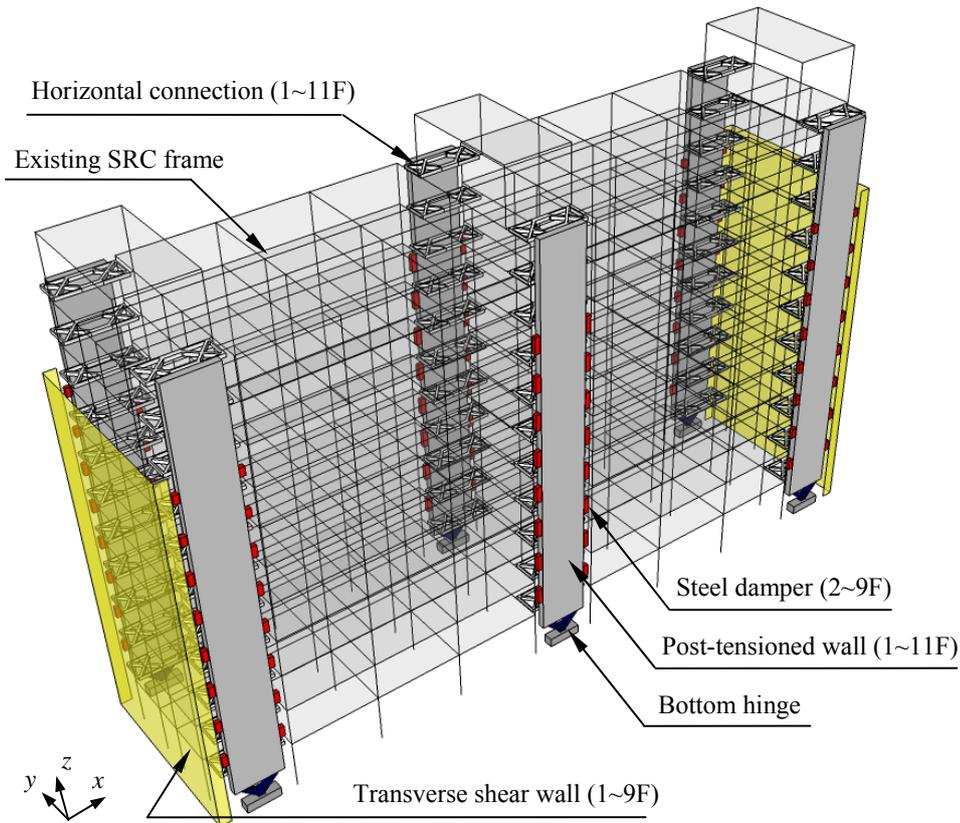
The structural layout of the original frame is feathered with six slots distributed along the perimeter ([Figure 2](#)). This makes the attachment of pin-supported walls much easier. Six post-tensioned concrete walls with bottom hinges are installed in those slots and connected to the existing frame at each floor level by horizontal trusses behind them. Shear-type steel dampers are installed in the gaps between the pin-supported walls and adjacent SRC columns as well as between the walls and added transverse shear walls at both ends. The main components of the retrofitting plan, as shown in [Figure 2](#), are visible from outside the building so passersby can appreciate the engineering solution.

Figure 2. Retrofit plan of G3 Building.

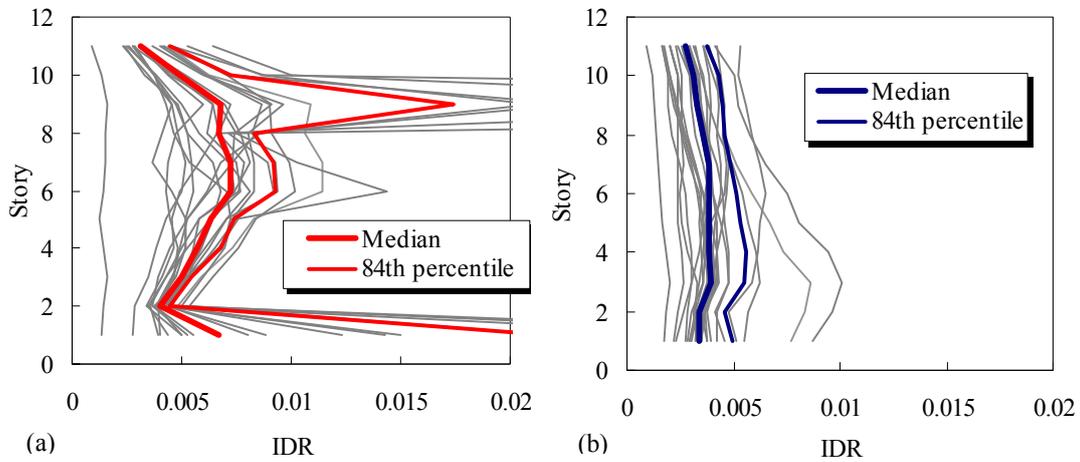
Performance Evaluation. Nonlinear dynamic analysis with one code-stipulated and two site-specific ground motions was carried out to assist the determination of major parameters of the retrofitting parts. More extensive analysis was then carried out to better evaluate the seismic performance of the G3 Building before and after the retrofit. Detailed nonlinear model was built in ABAQUS 6.8 and 22 ground motions (FEMA P605, 2009) which were scaled to have $PGV = 50$ cm/s were used for the evaluation. The readers are referred to Qu et al. (2012) for more details of the analysis model. The displacement responses of the building before and after the retrofit are compared in Figure 3 in terms of maximum inter-story drift ratio (IDR). The median and 84th percentile responses are also plotted. The original structure experiences extremely large IDRs in certain stories under many of the ground motions, indicating collapse at these stories (Figure 3(a)). In contrast, the distributions of IDRs over the height of the retrofitted building under various ground motion records are much more uniform (Figure 3(b)).

Figure 3. Inter-story drift ratios (IDR) of G3 Building before and after being retrofitted: (a) existing (original) structure and (b) retrofitted structure.

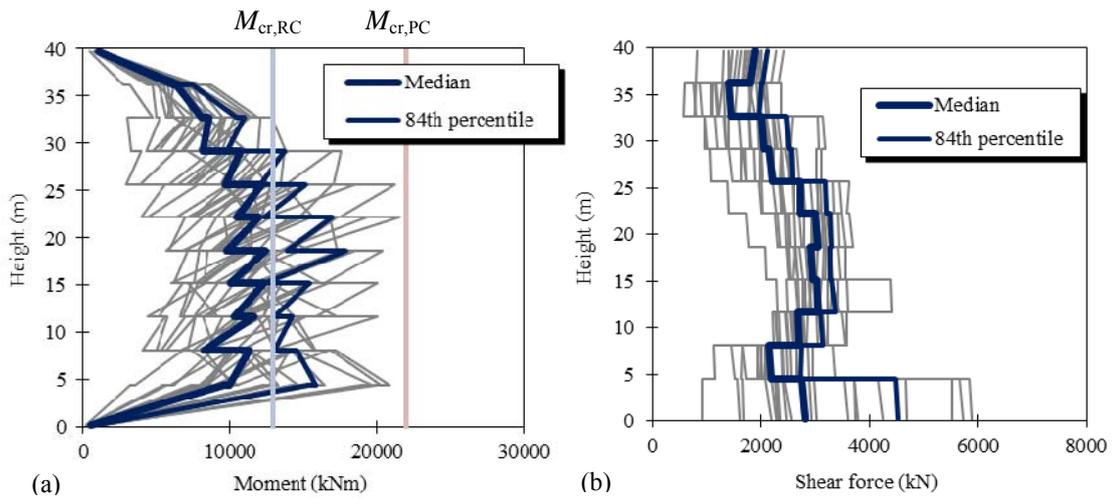
Post-tensioned Concrete Walls. The numerical analysis results were used in turn to determine the required capacity of the pin-supported walls. The moment and shear demand for the pin-supported walls are shown in Figure 4. There is large moment demand in the middle part of the wall while the shear demand is large at the base as well as in some middle stories. The final design of the wall section is shown in Figure 5. All six pin-supported walls have identical cross sections of 4300 mm in width and 600 mm in depth. The total cross-sectional area of the pin-supported walls at each story is about 50% to 61% of that of the original SRC columns from the lower to upper stories. Concrete with 36 MPa nominal compressive strength is used. Each wall is prestressed by six units of post-tensioning tendons. Each unit consists of 30 strands each 12.7 mm in diameter. Initial pre-stressing force of no less than 18000 kN per each wall was introduced primarily to prevent cracking and consequent stiffness degradation of the walls under strong earthquakes. By the pre-tensioning, the cracking moment of each wall is increased by about 70% from

$M_{cr,RC} \approx 13000$ kNm to $M_{cr,PC} \approx 22000$ kNm. As can be seen in Figure 4(a), the increased cracking moment, $M_{cr,PC}$, is even greater than the largest moment demand obtained in the analysis.

Figure 4. Strength demand for pin-supported walls: (a) Moment and (b) Shear force.

The tooth-like bearing is made of cast iron NCH490 with nominal yield strength of no less than 325 MPa. It consists of two separated tooth-shaped pieces (the lower and upper pieces), which interlock with several teeth and a separated stopper in the middle to prevent slip in the out-of-plane direction (Figure 7). The teeth in the lower piece are 20 mm longer than are those in the upper one to create a small gap, and their tips are chamfered to allow rotation of the upper piece. The shear resistance of a single pair of teeth (i.e., at the critical shear surface in Figure 7) is confirmed to be greater than maximum shear demand and is about 2.7 times the average shear demand as shown in Figure 4(b)..

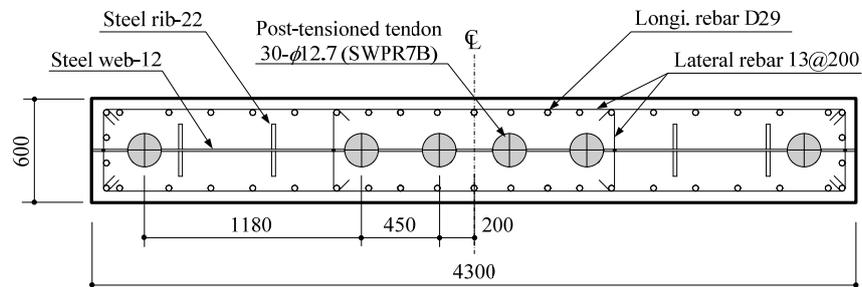
Figure 5. Cross section of post-tensioned wall.

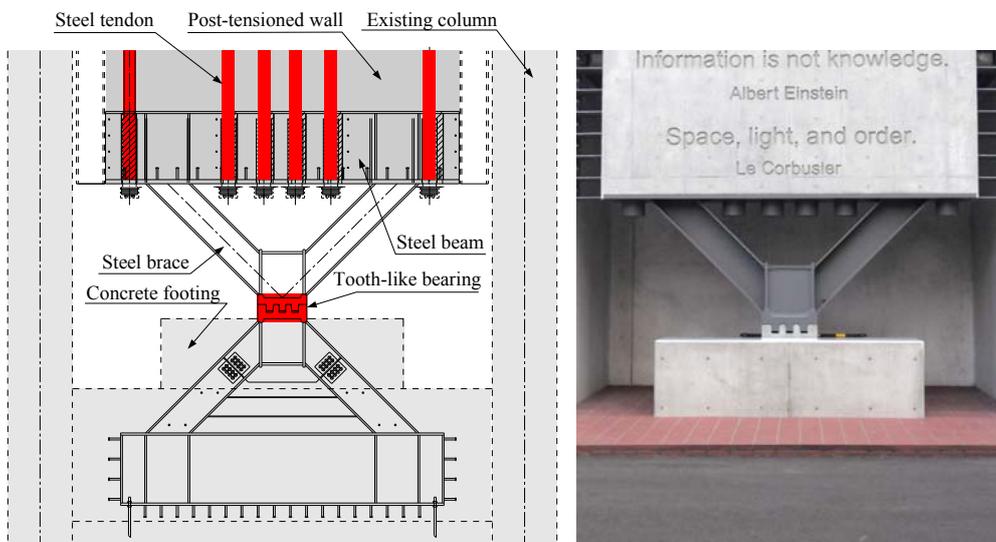
Connections for Pin-supported Walls. Pin-supported walls are connected to the foundation and the existing frame. The bottom hinge is made of two pairs of steel braces contacting each other through a tooth-like bearing. Details and a photo of one of the completed bottom hinges are shown in Figure 6.

Figure 6. Bottom hinge.

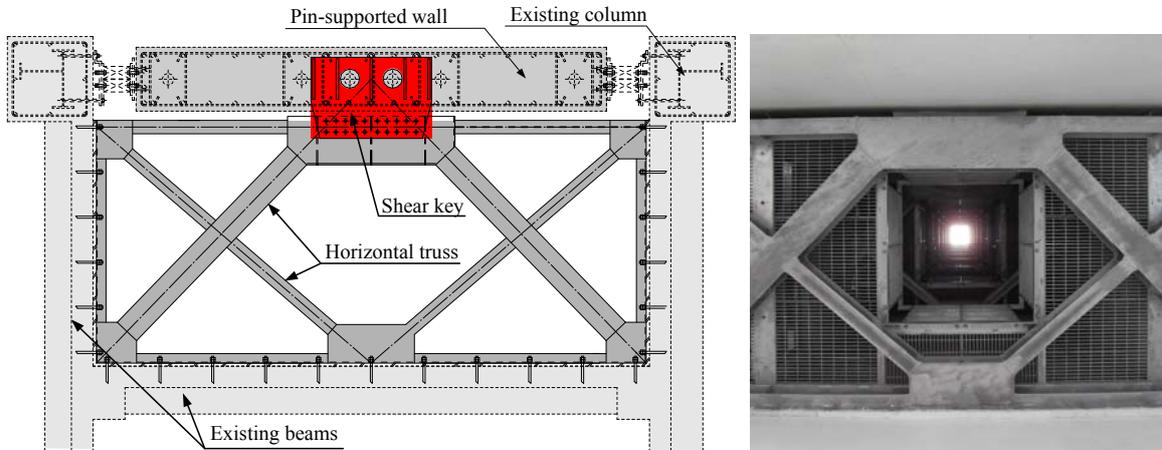
Pin-supported walls are connected to the existing frame mainly by horizontal connectors at each floor level behind them. Each connector consists of a horizontal truss and a steel shear key (Figure 8). The horizontal truss is firmly anchored to the original SRC beams. Steel shear keys are used to connect the horizontal trusses and pin-supported walls, which are expected to impose very small rotational constraints for pin-

supported walls. The principal functions of the horizontal connectors are to transmit lateral forces between the pin-supported walls and the SRC frame and to provide out-of-plane support for the walls.

Figure 8. Horizontal connector.

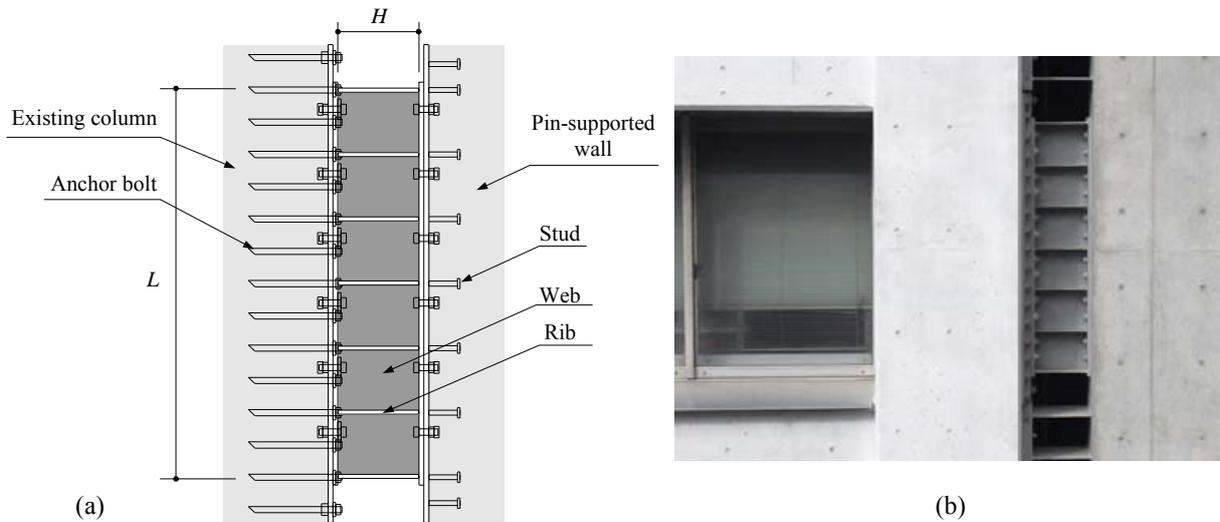
Shear-type Steel Dampers. Shear-type steel dampers are aligned on both sides of each pin-supported wall. Low yield steel with 130 MPa nominal shear strength is used. Steel webs 6 mm thick, which are stiffened by ribs at 250 mm spacing, function as energy dissipaters. The web height H is 312 mm for all the dampers while the length L varies from 750 mm to 1500 mm (Figure 9(a)). Table 1 lists the web length L of steel dampers in different locations. Figure 9(b) is a photo of an installed steel damper with $L = 1500$ mm. Cyclic loading test of the steel dampers reveals that the nominal shear capacity of the damper can be satisfactorily retained at up to 9% shear strain, which is about 58 times the yield shear strain of the damper. Most earthquake input energy is expected to be dissipated by these steel dampers.

To avoid uplift of the pin-supported walls due to damper forces, which might lead to dislocation of these walls from the pin bearings, the steel dampers are always arranged on both sides of the walls, even for walls at both ends of the building, so that the damper forces on both sides of a wall form a force pair and the resultant vertical force on the wall becomes insignificant. Besides, vertical ground motion-induced forces on a pin-supported wall can be resisted by the dampers, the total yield strength of which is more than five times the self-weight of the pin-supported walls at the center and about three times that of the walls at both sides.

Figure 9. Completed steel damper with $L = 1500$ mm.

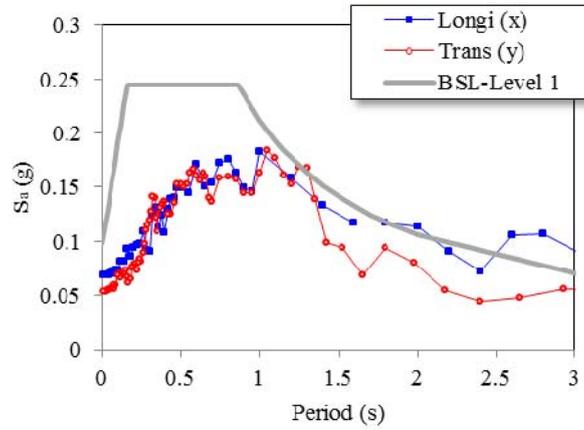
Five accelerographs, each with three channels for the three translational degrees of freedom, were installed in the basement (B1F), on the 2nd, 5th, 8th and 11th floor of the G3 Building when the retrofit was completed. Taking the records at the basement level as the ground motions, the peak ground acceleration (PGA) and the peak ground velocity (PGV) is 67.3 cm/s^2 and 14.4 cm/s in the longitudinal (x) direction and is 52.8 cm/s^2 and 12.7 cm/s in the transverse (y) direction, respectively (Miura et al., 2011). Figure 10 compares the acceleration response spectra of the recorded ground motions (B1F records) with the Level I design spectrum prescribed in Building Standard Law of Japan. In both directions, the spectra of the records were much lower than the design spectrum in period range below 1.0 s. In addition, the structure seems to have experienced quite similar shaking in both directions.

Figure 10. Acceleration spectra of recorded ground motion in longitudinal (x) and transverse (y) directions (5% damping)

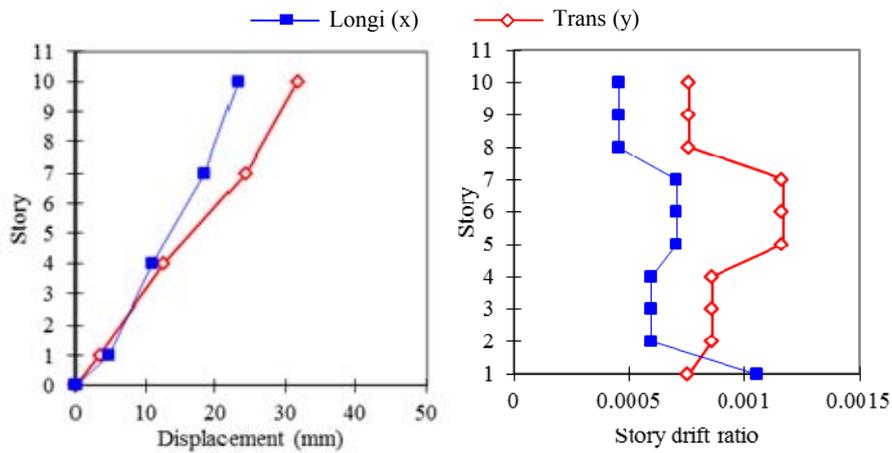
The accelerograms are processed by 4th order Butterworth high-pass filter before they are integrated to get the displacement response. Filtered accelerograms are integrated twice to obtain the displacement response. Numerical integration with trapezoidal rule is used and time increment Δt is set to be 0.01 s. The maximum lateral displacement in both x - and y -direction is depicted in Figure 11. The building exhibited different story drift distribution along the height in orthogonal directions. This was mainly a consequence of story stiffness distribution because the building remained essentially elastic during the earthquake.

Figure 11. Recorded peak motions of G3 Building: (a) lateral displacement and (b) story drift ratio.

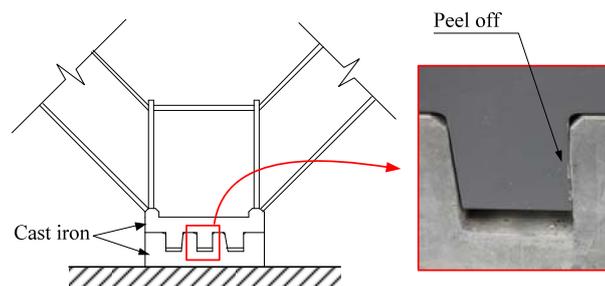
The building was inspected for seismic damage immediately after the Tohoku earthquake. Many minor cracks of width less than 0.2 mm were observed near the bottom of the conventional fixed-base walls at both ends of the building in the transverse direction, while on the other hand, no visible damage was observed on the pin-supported walls in the longitudinal (x) direction except that the painting of the bottom bearing was slightly peeled off, indicating that the bearing may have rotated as expected during the earthquake (Figure 12). In addition, diagonal rust was observed on the steel web plates of several steel dampers at lower stories (Figure 13), which indicated that these web plates may have yielded during the earthquake and the protective painting along the directions of principle strain was peeled off.

Figure 12. Peel off of painting of bottom tooth-like hinge (north, center).

The retrofitted building suffered moderate shaking during the 2011 Tohoku earthquake. In contrast to the many visible cracks on the conventional shear walls in the transvers direction, the pin-supported walls in the longitudinal direction sustained no visible damage. The peeling of protective paint on the cast iron hinges and on some steel dampers suggests that the system worked as expected under shaking.

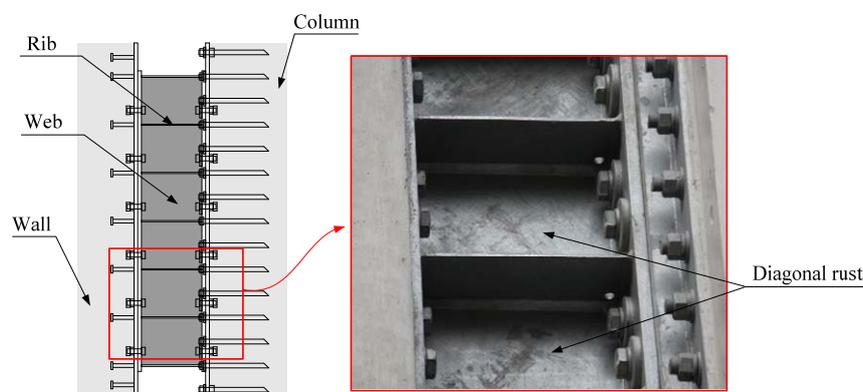
Figure 13. Diagonal rust marks on web plates (north, center at 2F).
