Preliminary investigation of seismic damage to two steel space structures during the 2013 Lushan earthquake

Abstract: Severe damage to steel space structures is rarely reported when compared to other structural systems damaged during past major earthquakes around the world. Two gymnasiums of steel space structures in downtown Lushan County that were damaged during the 2013 *M*7.0 Lushan earthquake in China were investigated and the observations are summarized in this paper. Typical damage to these two steel space structures ranges from moderate to severe. Moderate damage includes global buckling and dislocation of bolted connections of truss members, and inelastic elongation of anchor bolts and sliding of pedestal plates of supports. Severe damage includes member fracture caused by local buckling, and fracture failure of anchor bolts and welds. The distribution of structural damage to these two structures is described in detail and future research opportunities are suggested.

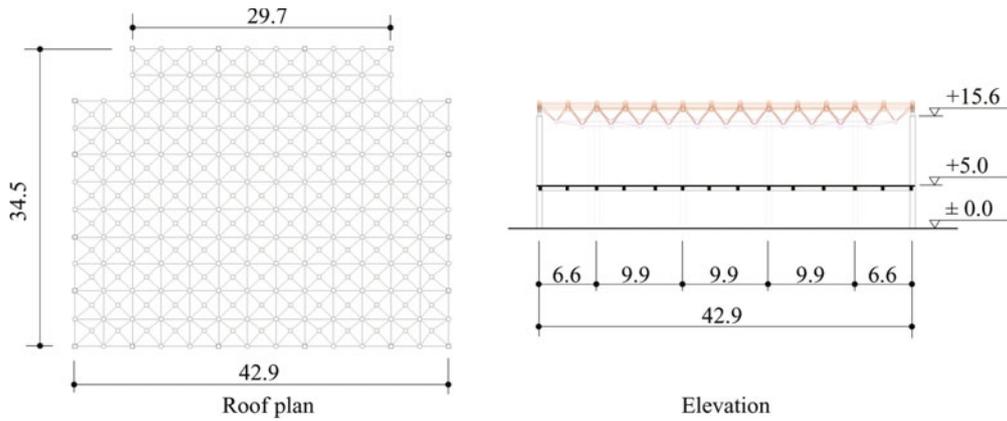
Fig. 1 Structural layout (left) and profile (right) of the Lushan Middle School gymnasium (length unit: m)

The Lushan Middle School gymnasium is a two-story reinforced concrete (RC) moment-resisting frame building that was designed and constructed after the 2008 *M*8.0 Wenchuan earthquake, with financial support from Macao. Its first story was occupied as a café and its second story was a gymnasium that included a basketball field. The roofing system is a double layer steel grid structure (denoted as Structure A, hereafter) resting on eighteen supports on top of the RC columns (Fig. 1). The double layer grid is composed solely of square pyramids. The bolted spherical bearing at each support is welded to a cruciform steel stand with a base plate fastened to a steel plate embedded in the top of the RC column by four ϕ 24 anchor bolts. The top layer of the grid was covered by profiled steel sheets, which were heavily damaged during the earthquake and had been removed at the time of inspection about three weeks after the earthquake. Primarily as a result of the loss of the roof, the occupancy of the building was suspended after the earthquake, although the RC frame structure remained essentially intact. In addition, Structure A sustained severe seismic damage including global buckling (Fig. 2(a)) and dislocation of truss members

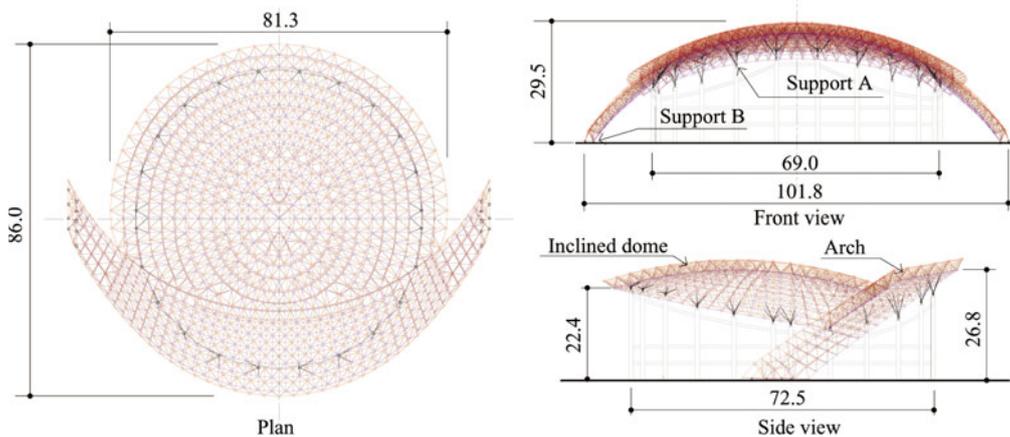
Fig. 4 Structural layout and profiles of Lushan Gymnasium Structure B (length unit: m)

Like Structure A, the Lushan Gymnasium was constructed after the 2008 Wenchuan earthquake as part of the reconstruction efforts in the earthquake affected area. The steel structure of the gymnasium is composed of a double layer lattice shell, which can be considered as a combination of an inclined dome and an arch (Fig. 4). Both the dome and the arch are primarily composed of square pyramid units. Tetrahedral units are also used in some transition zones. The lattice shell covers an ellipse-shaped indoor space of 69.0 m wide and 72.5 m long and is supported at different elevations on rubber cushions on top of 22 RC columns around the perimeter of the
