## ***TECHNICAL NOTE***

# **Seismic Damage of Masonry Infilled Timber Houses in the 2013 M7.0 Lushan Earthquake in China**

**Zhe Qu,<sup>a)</sup> M.EERI, Andreea Dutu,<sup>b)</sup> M.EERI, Jiangrong Zhong,<sup>c)</sup> Jingjiang Sun<sup>c)</sup>**

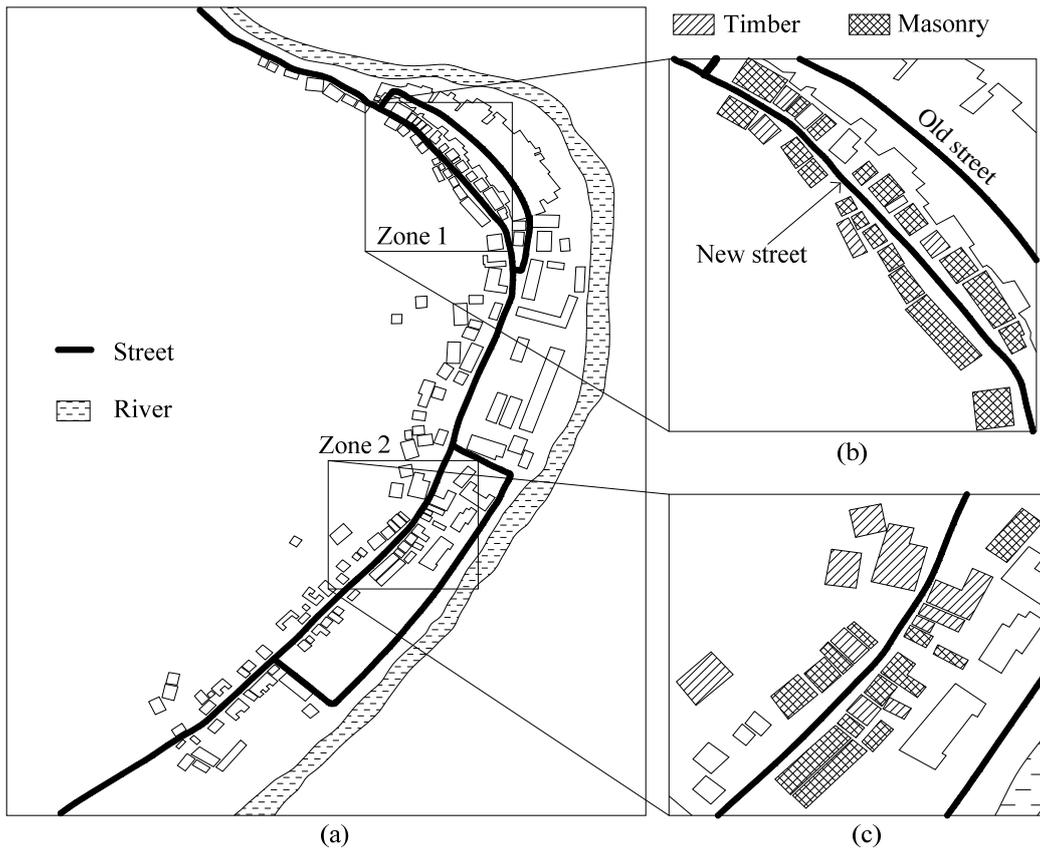
**Figure 9.** Map of inspected town of Shuangshi (a) overall view; (b) inspected houses in Zone 1 and (c) inspected houses in Zone 2.

In contrast to the satisfactory performance of the RC buildings, the rest of the buildings in Shuangshi sustained significant damage or even collapsed during the Lushan earthquake, the majority of which was made of either unreinforced masonry or timber frames and was un-engineered. Figure 9 gives a map of the buildings in Shuangshi, most of which lined up along the streets. Two areas were arbitrarily selected as the inspection zones, within which the seismic damage of every single building was inspected with a few exceptions when the access to the building was unavailable (the doors were locked). As a result, a total of 32 masonry houses (either URM or confined) and 14 timber frame houses were inspected. All inspected houses in the two zones are depicted in the zoom-in maps in Figure 9(b) and (c), where the structural types are distinguished by different fill patterns.
